SCANNING ELECTRON MICROSCOPY OF FRACTURE  
SURFACES OF CARBON COMPOSITE MATERIALS

NLR TR 76035 U

## SCANNING ELECTRON MICROSCOPY OF FRACTURE SURFACES OF CARBON COMPOSITE MATERIALS

W.G.J. 't HART

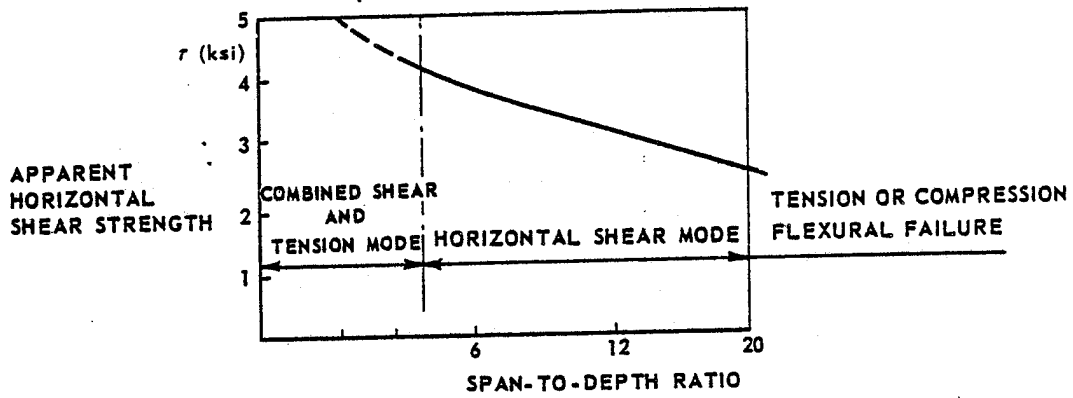
Figure 5 Shear strength as a function of the span-to-depth ratio

The quality of the fibre/matrix bond is usually measured by a three point bend test. Depending upon the span-to-depth ratio either shear failure or a flexural failure will occur (Fig. 5). If a sufficiently small ratio is chosen, a shear mode of failure is favoured in the neutral plane, resulting in a maximum value for the interlaminar shear stress (ILSS). Larger span-to-depth ratios result in a complex flexural failure, and the calculated ILSS decreases.

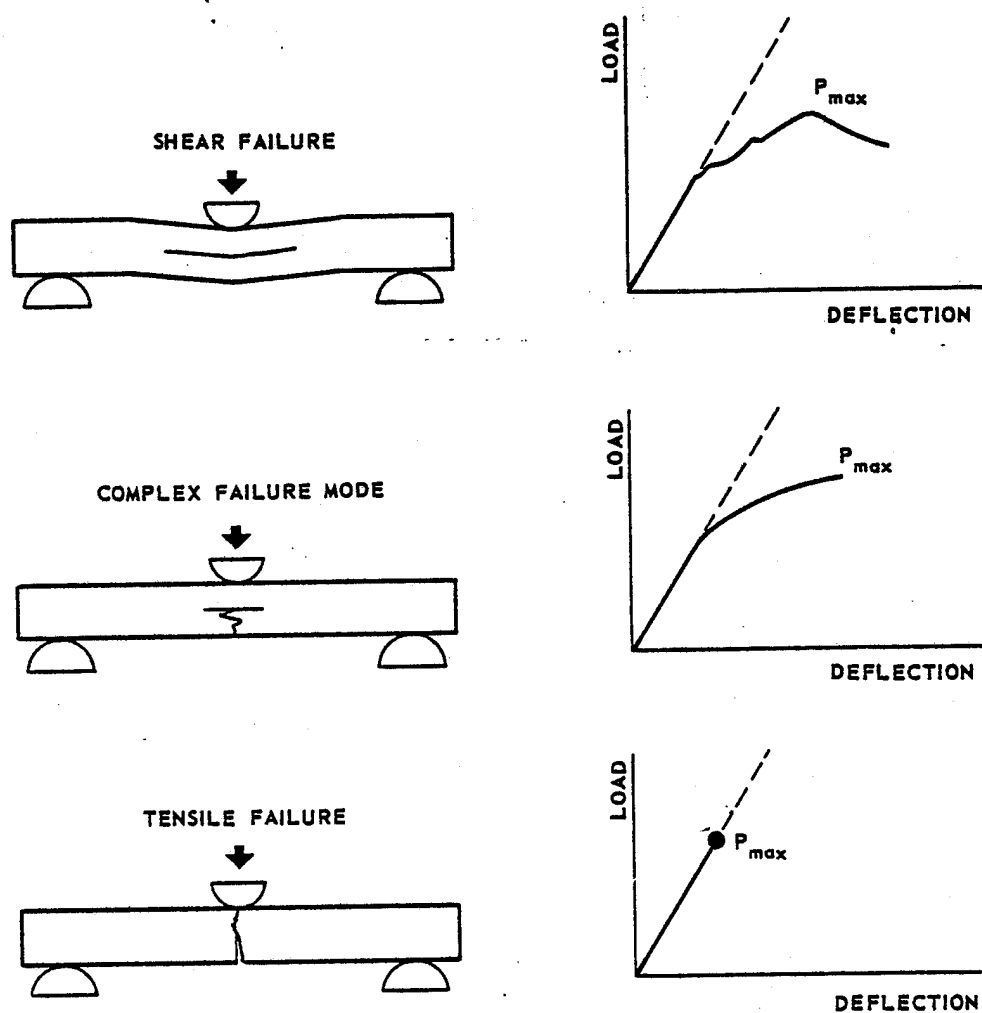
Figure 11 Types of failure in short-beam shear specimens of u.d. composite material

The ILSS and flexural strength were investigated by a three point bend test of a short beam specimen. It was anticipated that the fracture process might be a combination of shear and flexural fracture. The load-displacement curves associated with the different fracture modes are shown in figure 11.
